Keynote: Concertgebouw Amsterdam: History of the main hall and its acoustics; PART 2: Preserving the acoustics

Martijn VERCAMMEN¹; Margriet LAUTENBACH²; Rob METKEMEIJER

Peutz, The Netherlands

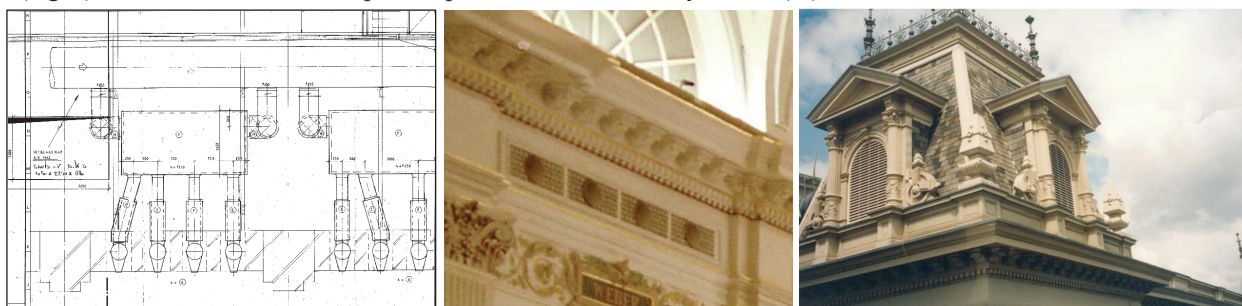
The hall did not have a ventilation system. In the early years, there was not even a wardrobe and people brought their wet clothes into the hall. In 1898 a satirical poem about the suffocating air in the hall was published (5). The hall was ventilated after each performance, but with the increasing number of performances, the need for better air quality in the hall was evident. An air handling system was developed with air nozzles high up in the side walls. The air inlets were connected to plenum boxes that are installed in the attic spaces adjacent to the hall. The acoustic requirement was a sound level of NR15/20 dB(A) in the hall, based on measured background noise. The air system was optimised in the Peutz acoustics laboratory. The 14 plenum boxes of 1780 m³/h each got two connections to the air supply at opposite sides to achieve equal air quantity through all nozzles (fig.5). The measured sound power per element was only 26 dB(A).

Figure 5. Left: Air inlet system in 1988; Middle: Air inlets after 1998, right: Air handling in the towers

The capacity of the air inlet system was increased from 24,000 to 35,000 m^3/h , and the nozzles were replaced by much larger cylindrical tubes. At the bottom of the walls, heating/ventilation units were placed. The larger holes in the ceiling enabled increased exhaust without increase of air velocity.
