## Acoustic adaptation of performance and lecture spaces in historical buildings

Historical buildings are an architectural form of heritage, where unique aesthetic spaces can be adapted to host new functions. This is a case study of a national heritage building in Sofia, Bulgaria, originally built as a private house and atelier for a famous sculptor. The building is currently adapted as a cultural center with a theatrical performance hall, an exhibition/lecture hall and a small music hall. The spaces need acoustic corrections in order to provide adequate performance. Due to aesthetic and historical reasons sound-absorbing panels should be designed and imported in the space in an appropriate manner. Room acoustic simulation software is used to locate the most effective positions of sound-absorbing panels, to reduce reverberation time and improve speech intelligibility.

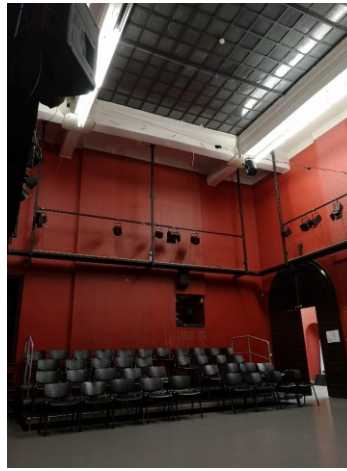
Figure 3 – The Large studio

The Large studio, figures 3 and 4, has a clear rectangular plan, large window openings providing natural light and illuminating the former working area. The space also has roof glazing over the bearing metal structure. The combined rehearsal room represents two connected rectangular volumes with floors and ceilings at different levels, respectively. All the walls are solid brick-built, plastered both in interior and exterior. During the adaptation in 2004 most of the original structures of the walls had been preserved. Only the Large studio breaks the original wall structure in an attempt to acoustically interfere with placing acoustic perforated panels on the walls for sound absorption. During the reconstruction, the original double-glazed window frames have been preserved, either with wooden or metal structure. There are curtains in front of the windows in the Large studio.
