## From acoustic brief to acoustic reality; experiences from advising clients on recently built concert halls in Scandinavia

Anders Christian GADE<sup>1</sup>

<sup>1</sup> Gade & Mortensen Akustik A/S, Denmark

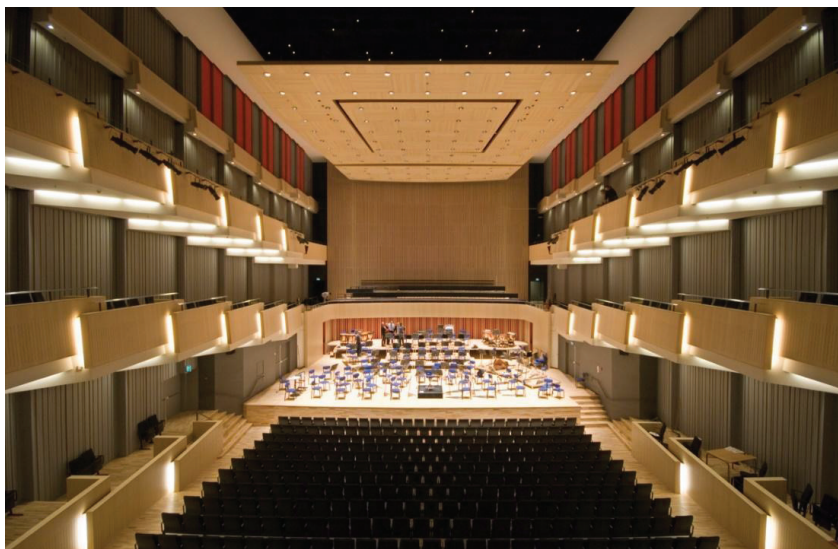
A photo from the finished hall is shown in Figure 1. As can be seen, the detailed shaping of the hall elements was well suited for building the hall from precast concrete elements, which contributed to keeping the building costs low.

Figure 1- Symfonisk Sal, Aarhus. View towards the stage

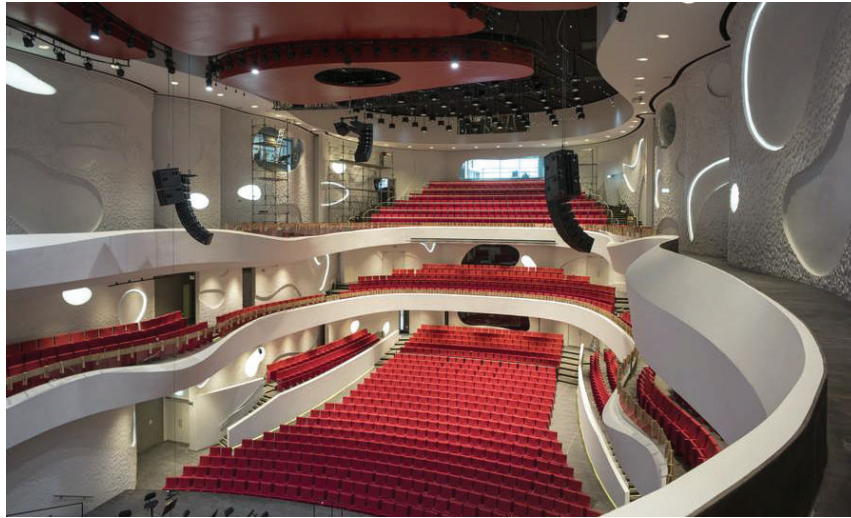
Contrary to Aarhus, the detailed shaping of the hall is more organic with many curved walls and balcony fronts as shown in Figure 3.

Figure 3 – The Large Hall, House of Music, Aalborg

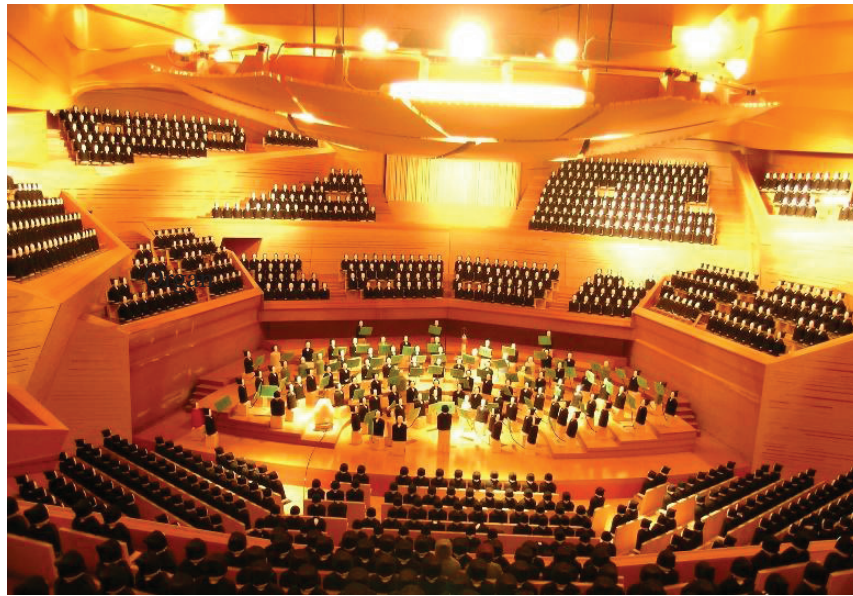
Figure 6 - DR concert hall 1:10 scale model with “orchestra” for stage acoustic measurements

Fortunately, the DR Symphony Orchestra members are generally happy about their new home. In our testing of the 1:10 scale model, we were much concerned about the convex canopy being placed quite high above the stage (typically about 15m above the stage floor); but it seems that the rather steep circular risers ensures free propagation of the direct sound between the players which compensates for the rather weak reflection from the canopy. In spite of low  $ST_{early}$  values on stage, the musicians find it easy to hear each other. Some musicians, though, lack the fullness which they have experienced e.g. in the new hall in Malmö (4).
