# Concertgebouw Amsterdam: History of the main hall and its acoustics

## PART 1: The early years: acoustic design and resolution of acoustic difficulties

Pamela CLEMENTS<sup>1</sup>, Martijn VERCAMMEN<sup>2</sup>

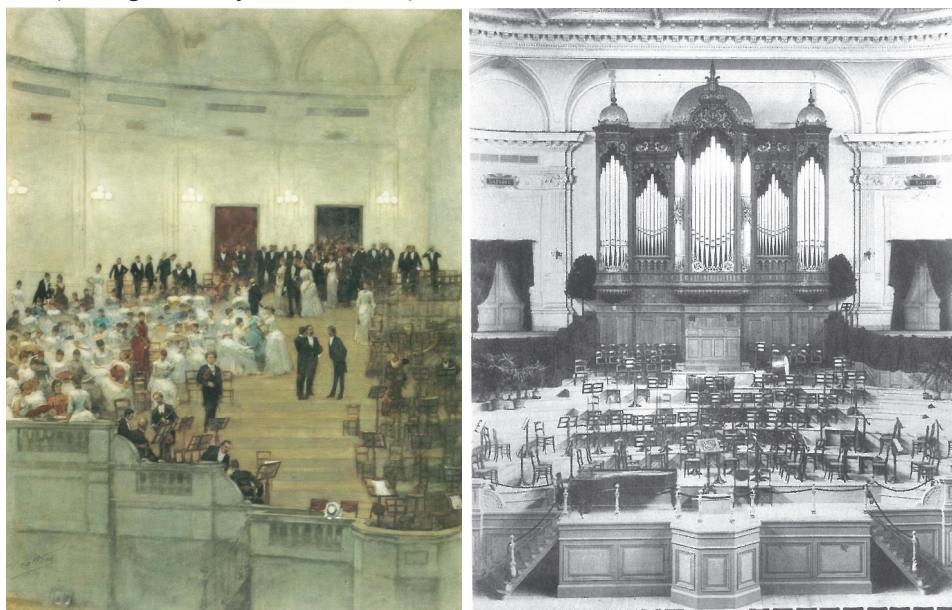
Figure 9. Left: Opening 11<sup>th</sup> of april 1888 (Aquarel N.van der Waay), Right: Photo of the interior in 1891 (with new organ), with screens, drapes and plants to help to control the acoustics.

Other early remedies included adding drapes (“portières”) at the entrance doors, building a low screen at the back of the orchestra, covered with thick drapes, and filling empty areas of the stage with potted plants, which it was hoped would “soak up the sound” (fig 9, right). Carpet was placed under the brass and percussion instruments. There was no sufficient budget for carpet along the corridors in the hall. Attendance at Concertgebouw Orchestra concerts continued to be poor, for a large part because of poor access roads. Only a few special performances drew a full audience. Financial difficulties were so severe at this time that the institution barely survived, and indeed in 1891 the orchestra’s contract was for a time dissolved.
